Lake Cascade Lake Vegetation Index Results (10-17-2016)

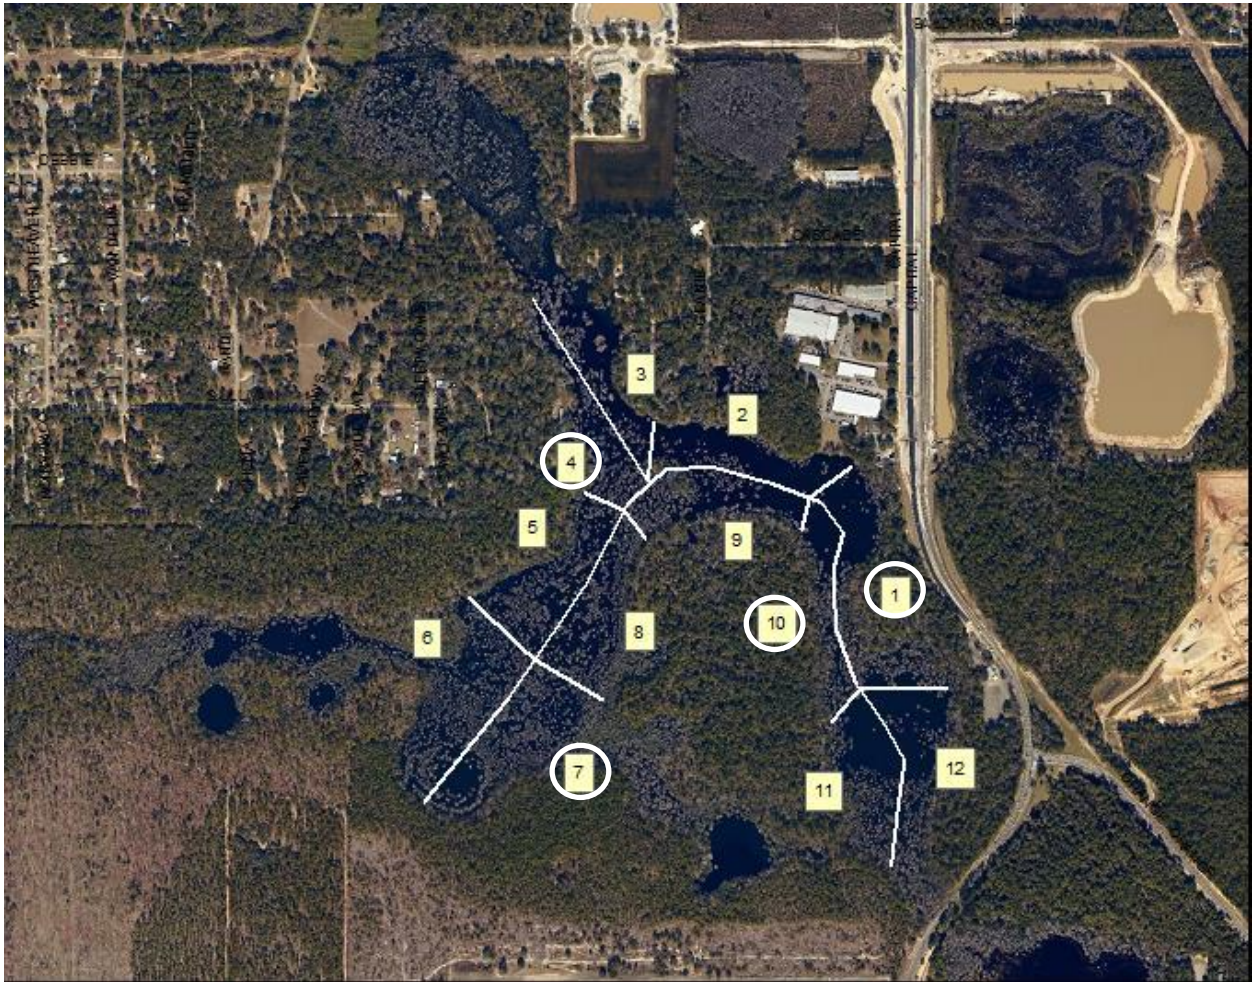
FIGURE 1. Lake Cascade showing unit divisions. Circled unit numbers denote surveyed units.

The LVI method is performed from a boat, and involves dividing a lake into 12 units and identifying plants in 4 of the 12 units (Figure 1). Plants are identified in the selected unit by a visual boat "drive by" and also via a transect approach. The resulting data is used to calculate the LVI and is evaluated according to the scoring system in Table 1.
